DEPARTMENT OF TRANSPORTATION**DIVISION OF ENGINEERING SERVICES**

Quality Assurance and Source Inspection

Contract #: 04-0120F4Cty: SF/ALA Rte: 80 PM: 13.2/13.9File #: 1x.28**WELDING INSPECTION REPORT****Resident Engineer:**Pursell, Gary**Address:** 333 Burma Road**City:** Oakland, CA 94607**Report No:** WIR-012664**Date Inspected:** 17-Mar-2010**Project Name:** SAS Superstructure**OSM Arrival Time:** 700**Prime Contractor:** American Bridge/Fluor Enterprises, a JV**OSM Departure Time:** 1530**Contractor:** American Bridge/Fluor Enterprises, a JV**Location:** Job Site

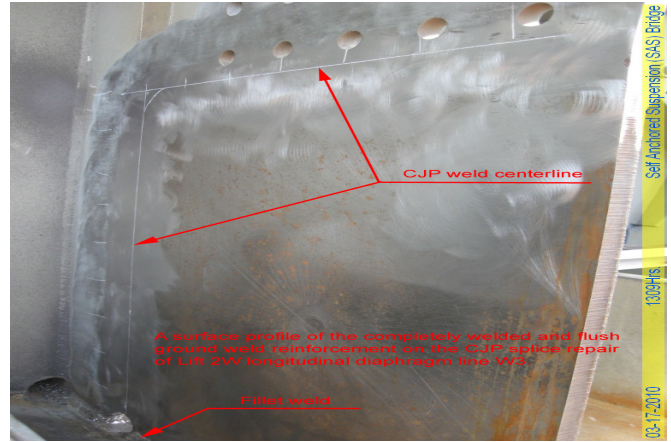
ABF/JV welder John Rosas flush grinding the weld reinforcement of the completed CJP splice joint repair at Lift 2W longitudinal diaphragm line 3, panel point 13.
